**UTILITY CONTRACTORS'  
ASSOCIATION OF ONTARIO**

## ToolboxTalk

### Shoring Box Collapse

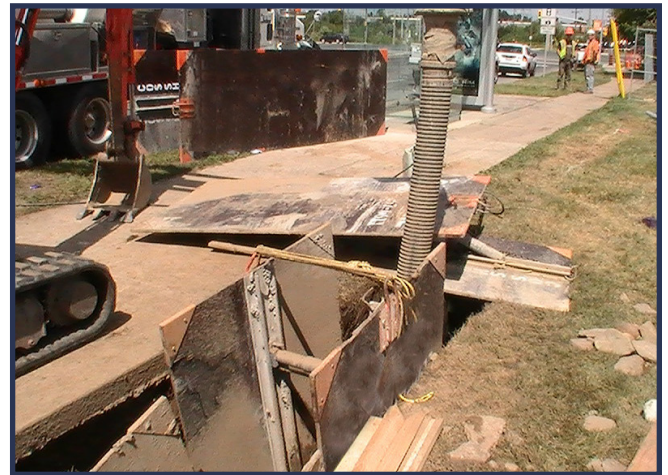
A worker was knocked over by a falling 8' x 4' Speed Shore shoring box.

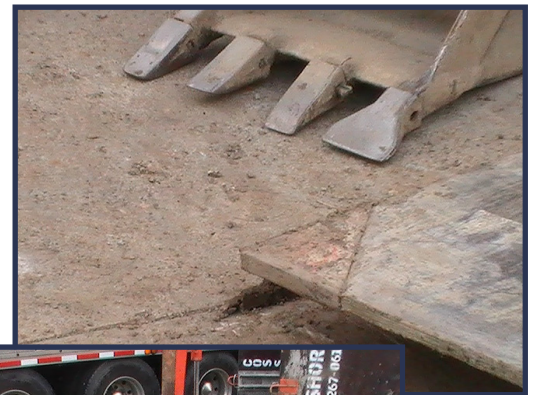
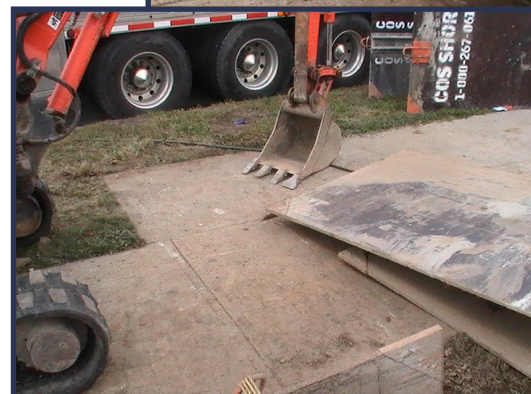
The shoring box had just been raised from a trench to excavate a little deeper. A Kubota U35 was used to hoist the shoring box out of the trench. A four-way lifting chain was used with a lifting ring hooked over the wide tooth of the excavator bucket. The shoring box was lifted out of the trench with the 8' length straight up and down. Once the shoring box had been lifted clear of the trench and set on the sidewalk adjacent to the trench, the lifting ring slipped from the tooth of the excavator allowing the box to collapse towards a worker, contacting him and pushing him back from the excavation. A second worker received scrapes on the forearms from the falling box while the foreman attempted to slow the descent of the box.

Teeth are not an appropriate attachment point for rigging hoists. Approved lifting points are to be used with appropriate lifting devices. In this case, a backhoe was on the site but was not used as it is not as easy to use as the mini-excavator.

If the lifting point had been attached to the backhoe through the lifting eye, the box would not have been capable of collapsing and falling.
